#2104 PUMP STATION 4002 REHAB (25% - SEPTEMBER 2024)

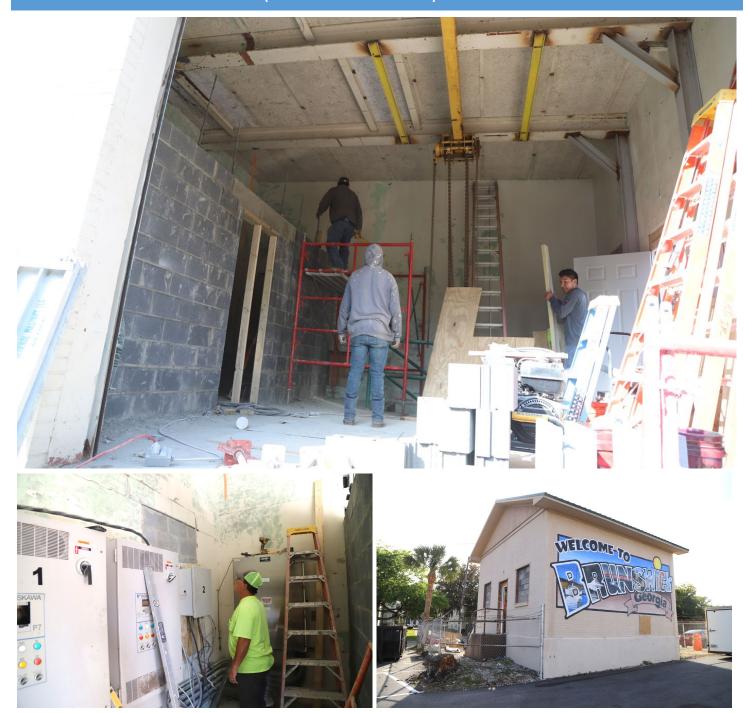
- 1. D Construction LLC (PopCo Subcontractor) Crewmembers work on the interior masonry wall formation for the instrumentation and control room.
- 2. James Merrit (PopCo Superintendent) inspects the masonry work and wall preparation activities for the upcoming interior stucco repairs.
- 3. Southeast view of the existing pump station construction activities existing door to be replaced, and windows are removed and blocked up.
